1. Cover Page

Type of Report:	White Paper-NEH SCHC Planning Grant
Grant Number:	PF-50424-14
Project Title:	Planning a Sustainable Preservation Environment for Arizona State Museum's Anthropological Photographs.
Project Director:	Teresa Kathleen Moreno
Grantee Institution:	University of Arizona, Arizona State Museum
Date Submitted:	February 20, 2019

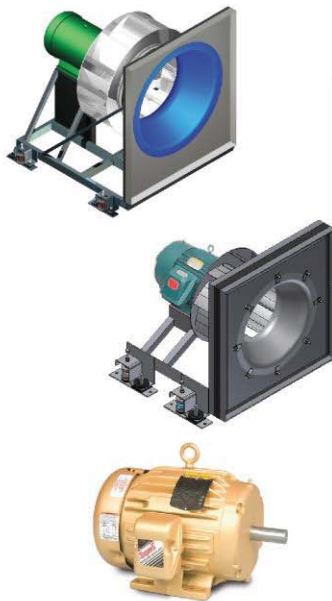
1.4 | Fan and Motor Assembly

All interior surfaces of the walls, and roof are insulated with neoprene coated, NFPA 90A approved insulation, unless otherwise noted in unit data sheet. **A**

All hardware provided is non-corrosive and all hinges and latches are adjustable. **D**

Access door to fan section has bolted hardware **C** in lieu of knurled knobs, to meet code requirement.

Removable panels are located on the opposite side of the coil connection, unless otherwise noted in mechanical drawing. **B**

Pans are constructed of 16 gauge 304 stainless steel, with stainless steel drain connection on one side. **E**

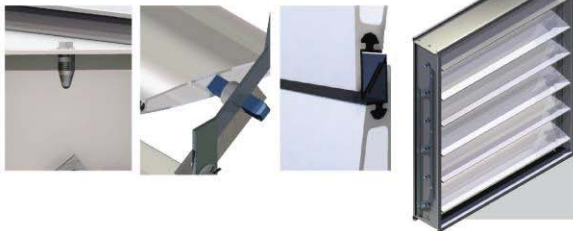
1.8 | Dampers

Dampers manufactured by Energy Labs have a 16 gauge galvanized steel frame, damper blades are extruded aluminum, nylon bushings and zinc plated shafts.

Aluminum dampers are light weight to reduce unit weights. Aluminum damper blades are much more resistant to corrosion.

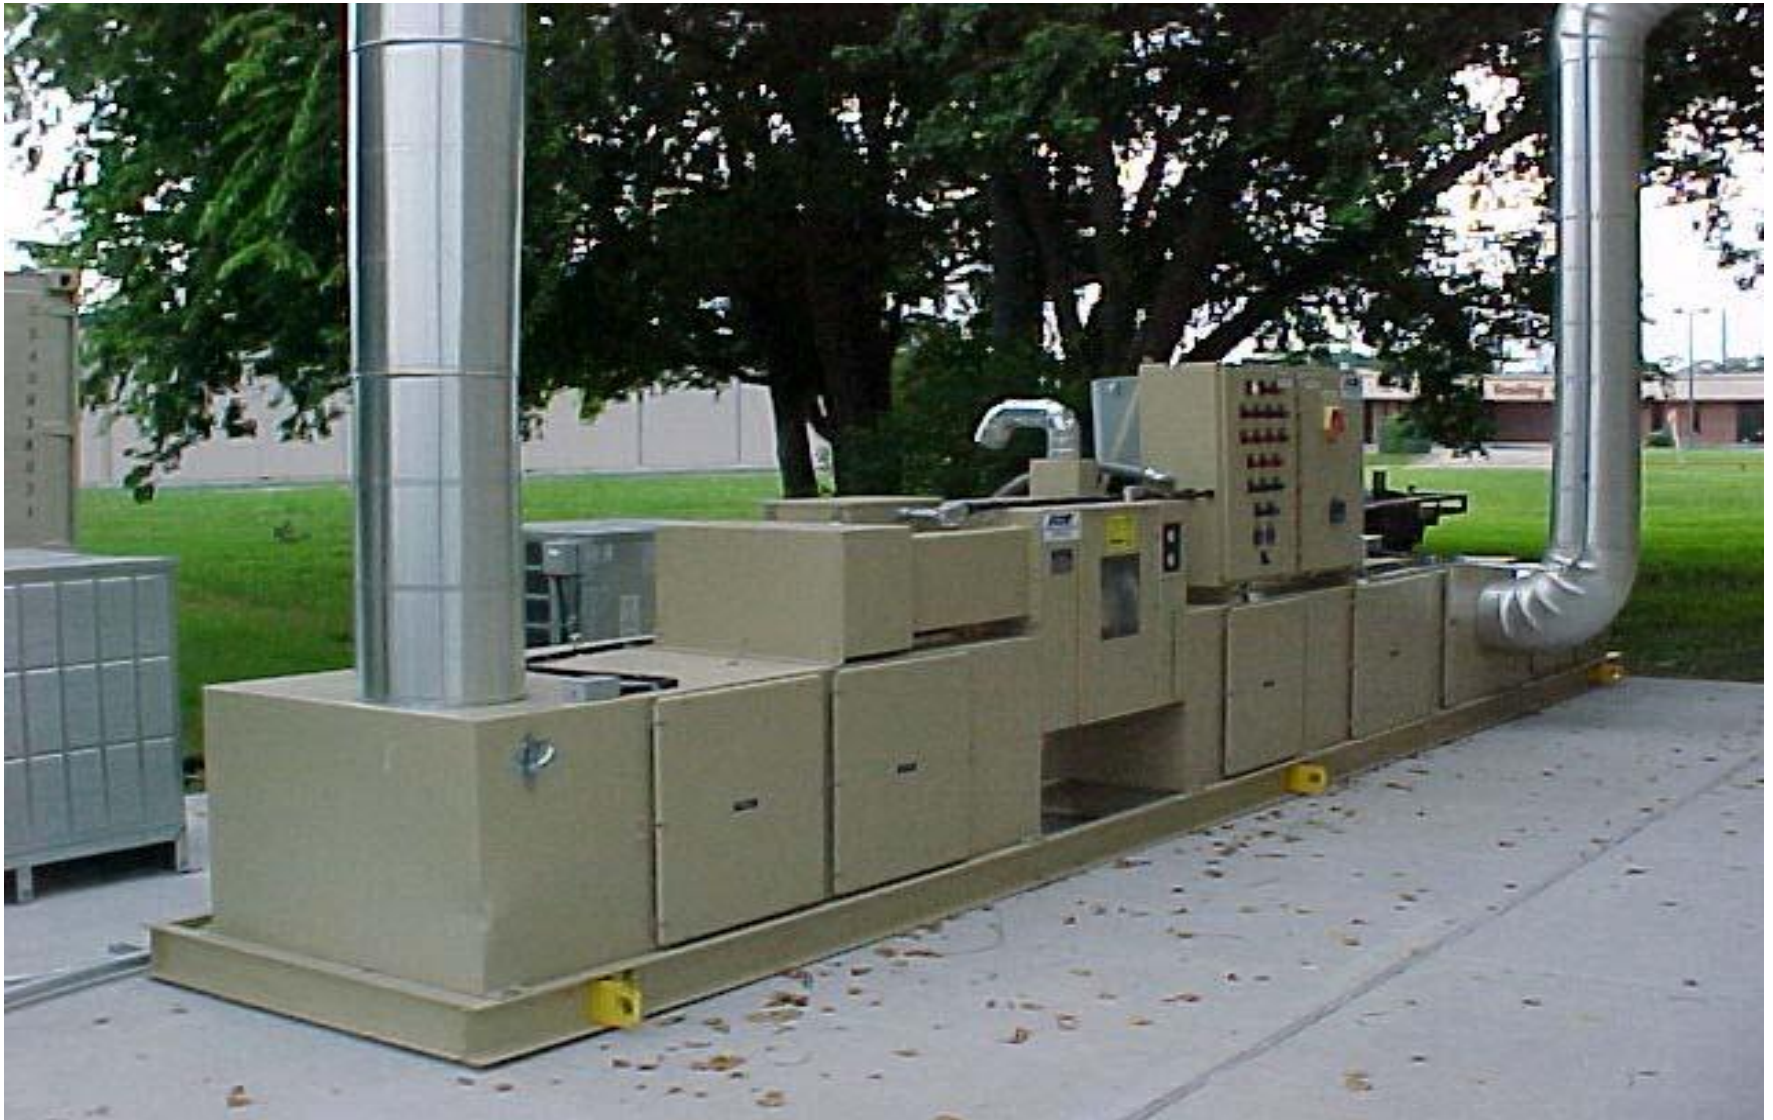
Temperature & Humidity Control System – SCS Houston, TX

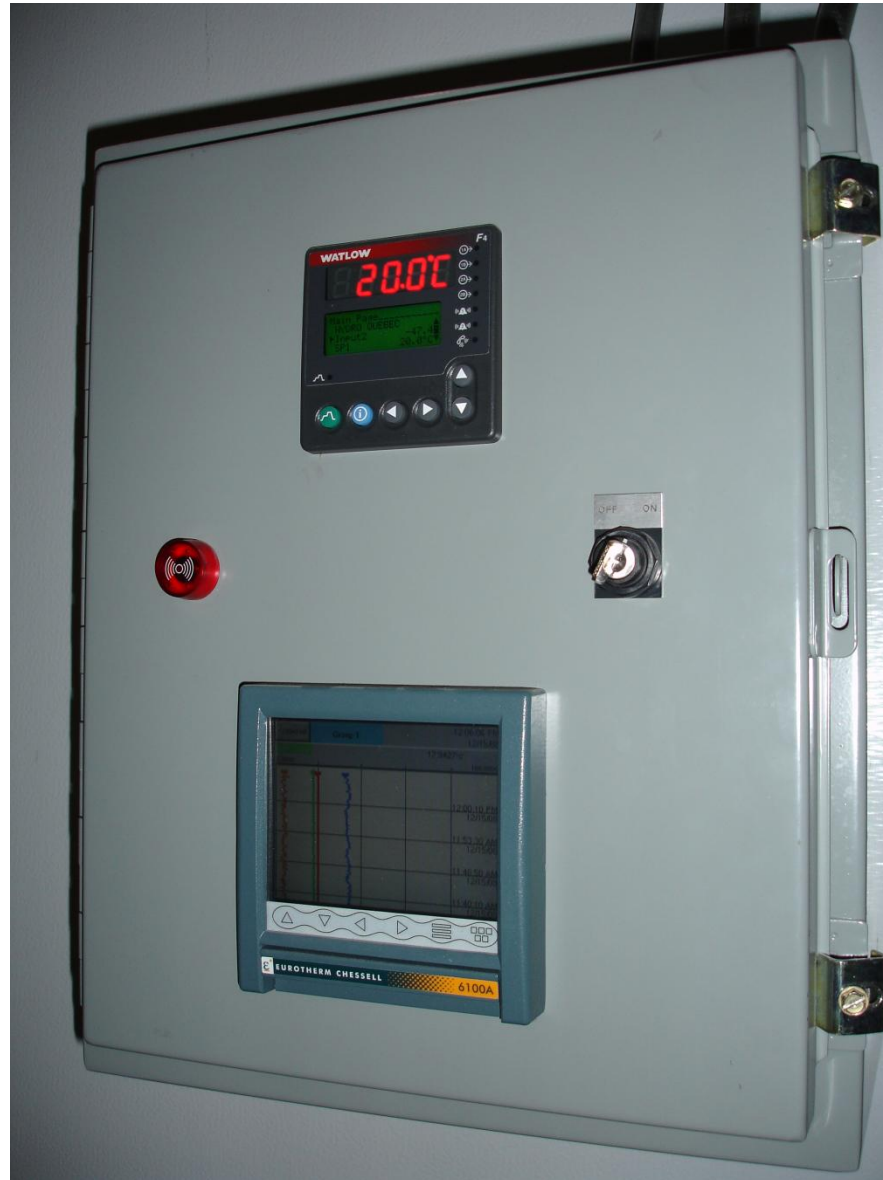
Dry Room Controller with Digital Display & Paperless Recorder

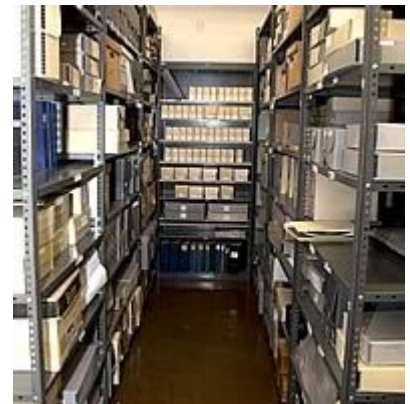
*One of five areas now holding
the photo collections
Photo by Jannelle Weakly*

The existing photographic collection is currently housed in five (5) separate locations shared between two (2) buildings, Building 26 (ASM North) and Building 30 (ASM South), in attempt to store similar collections together. Nearly all spaces currently exhibit room temperatures exceeding the recommendation for preservation, and most of these spaces are additionally prone to large changes in relative humidity, swinging from 20-30% most of the year then up to 60% from July to mid-September. These current spaces have been deemed unacceptable for image preservation as extended periods of exposure to high temperatures and humidity accelerate the rate of chemical decay of organic materials.
